# TECHNICAL INSPECTION REPORT

U.S.S. PENSACOLA (CA24)

TEST ABLE

OPERATION CROSSROADS

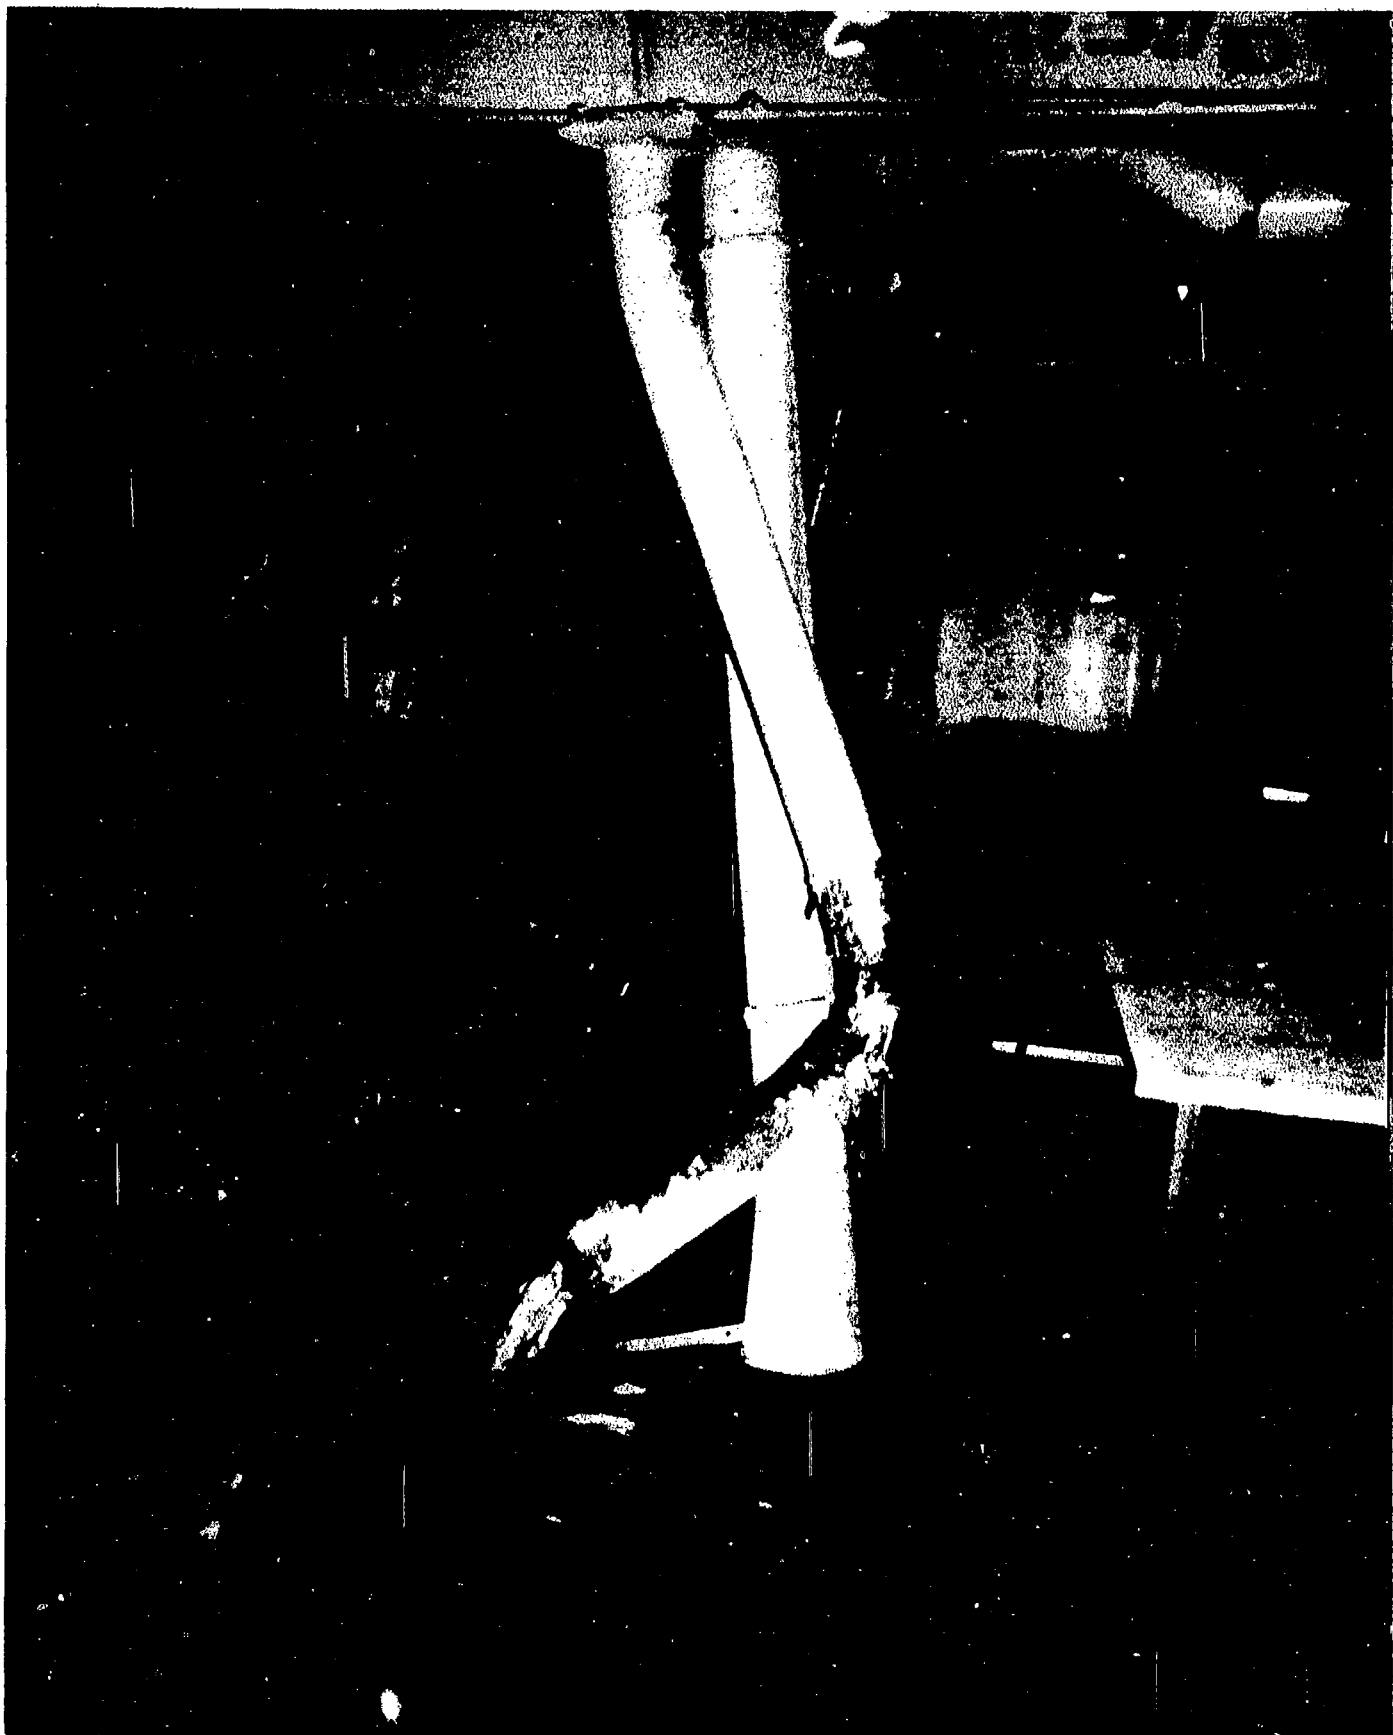
AA-CR-175-2178-2. Looking forward on 2nd deck showing failure of station at web frame 125.

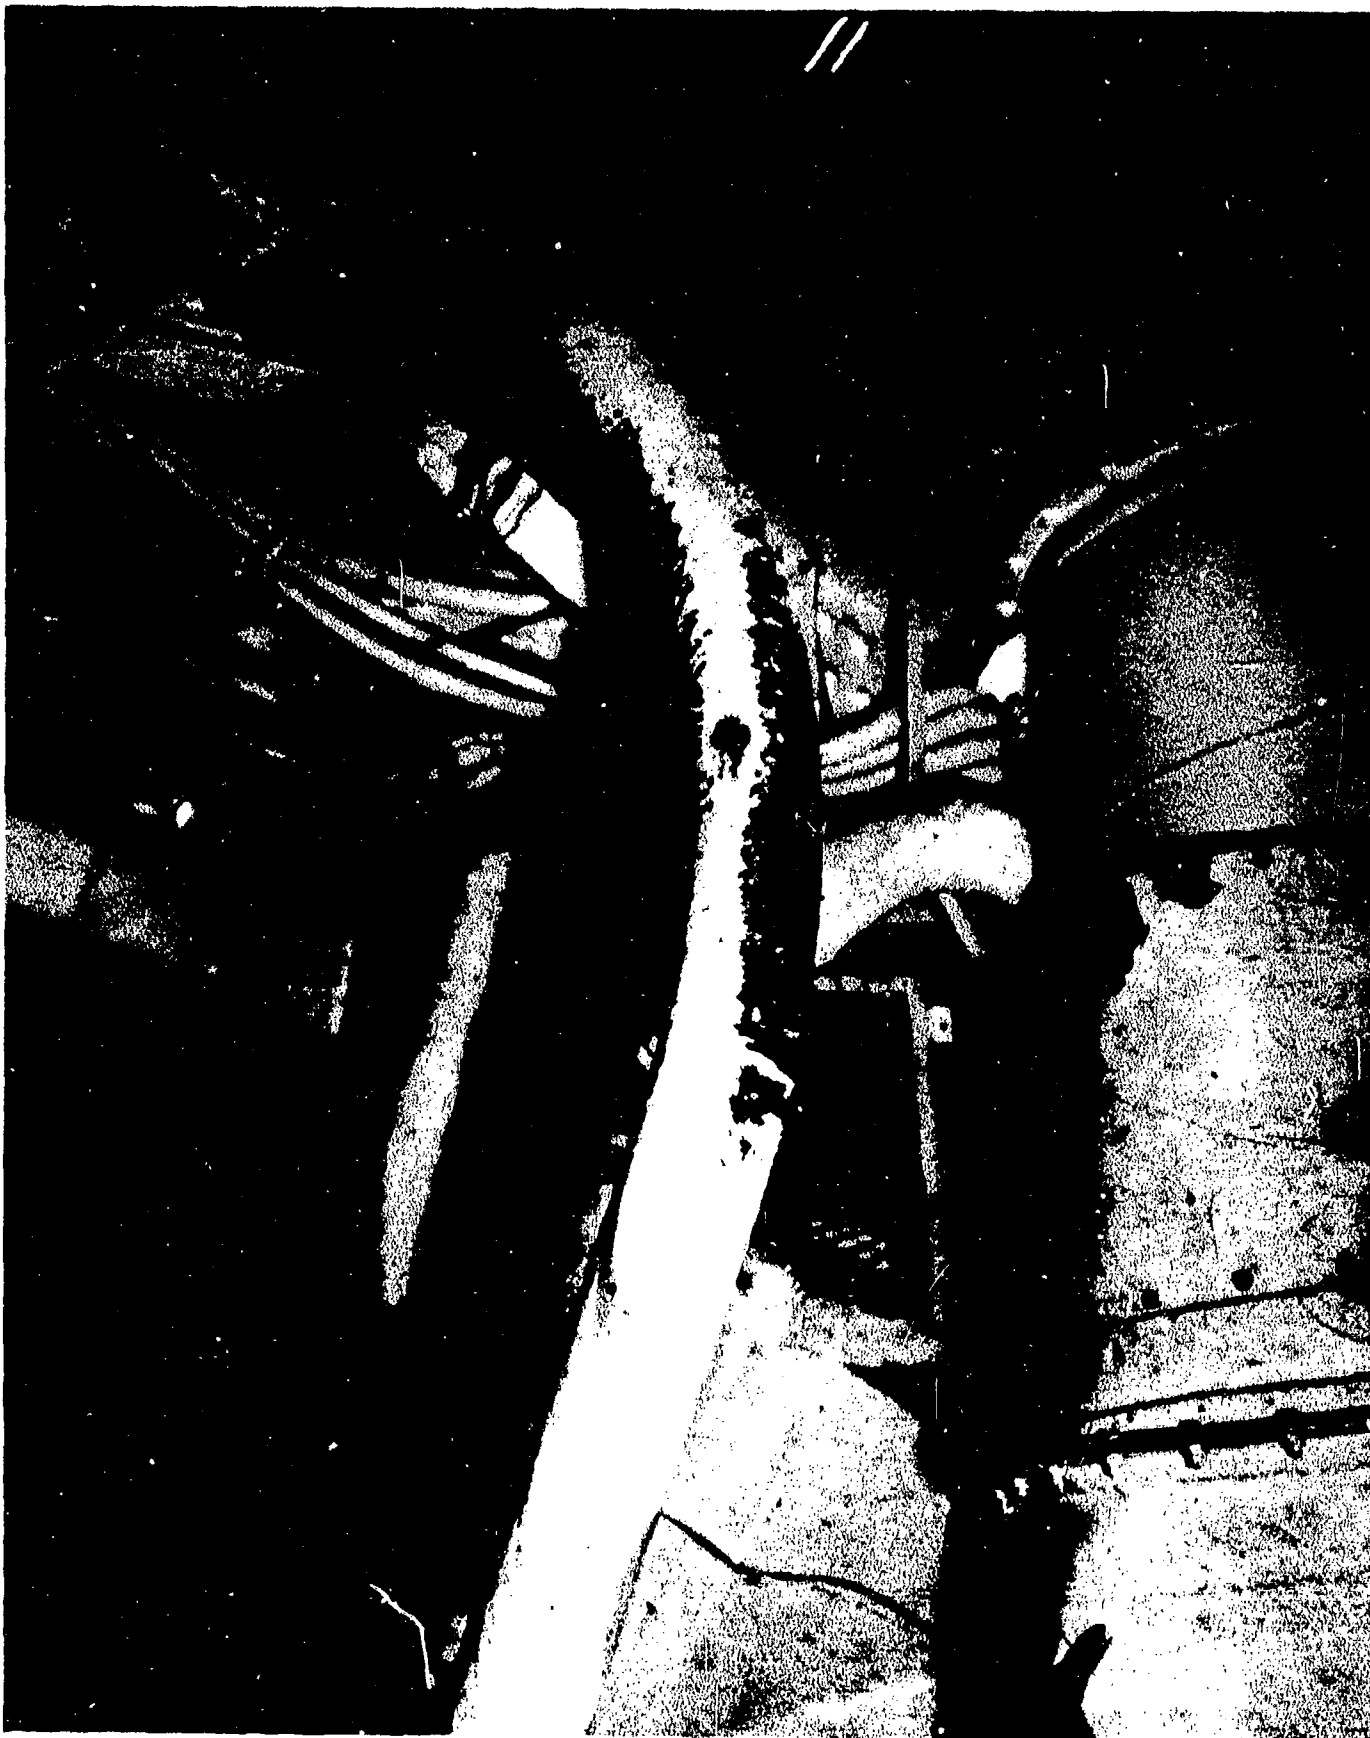
AA-CR-175-2178-11. Looking aft and to port on 2nd deck showing damage to centerline stanchion at frame 125.

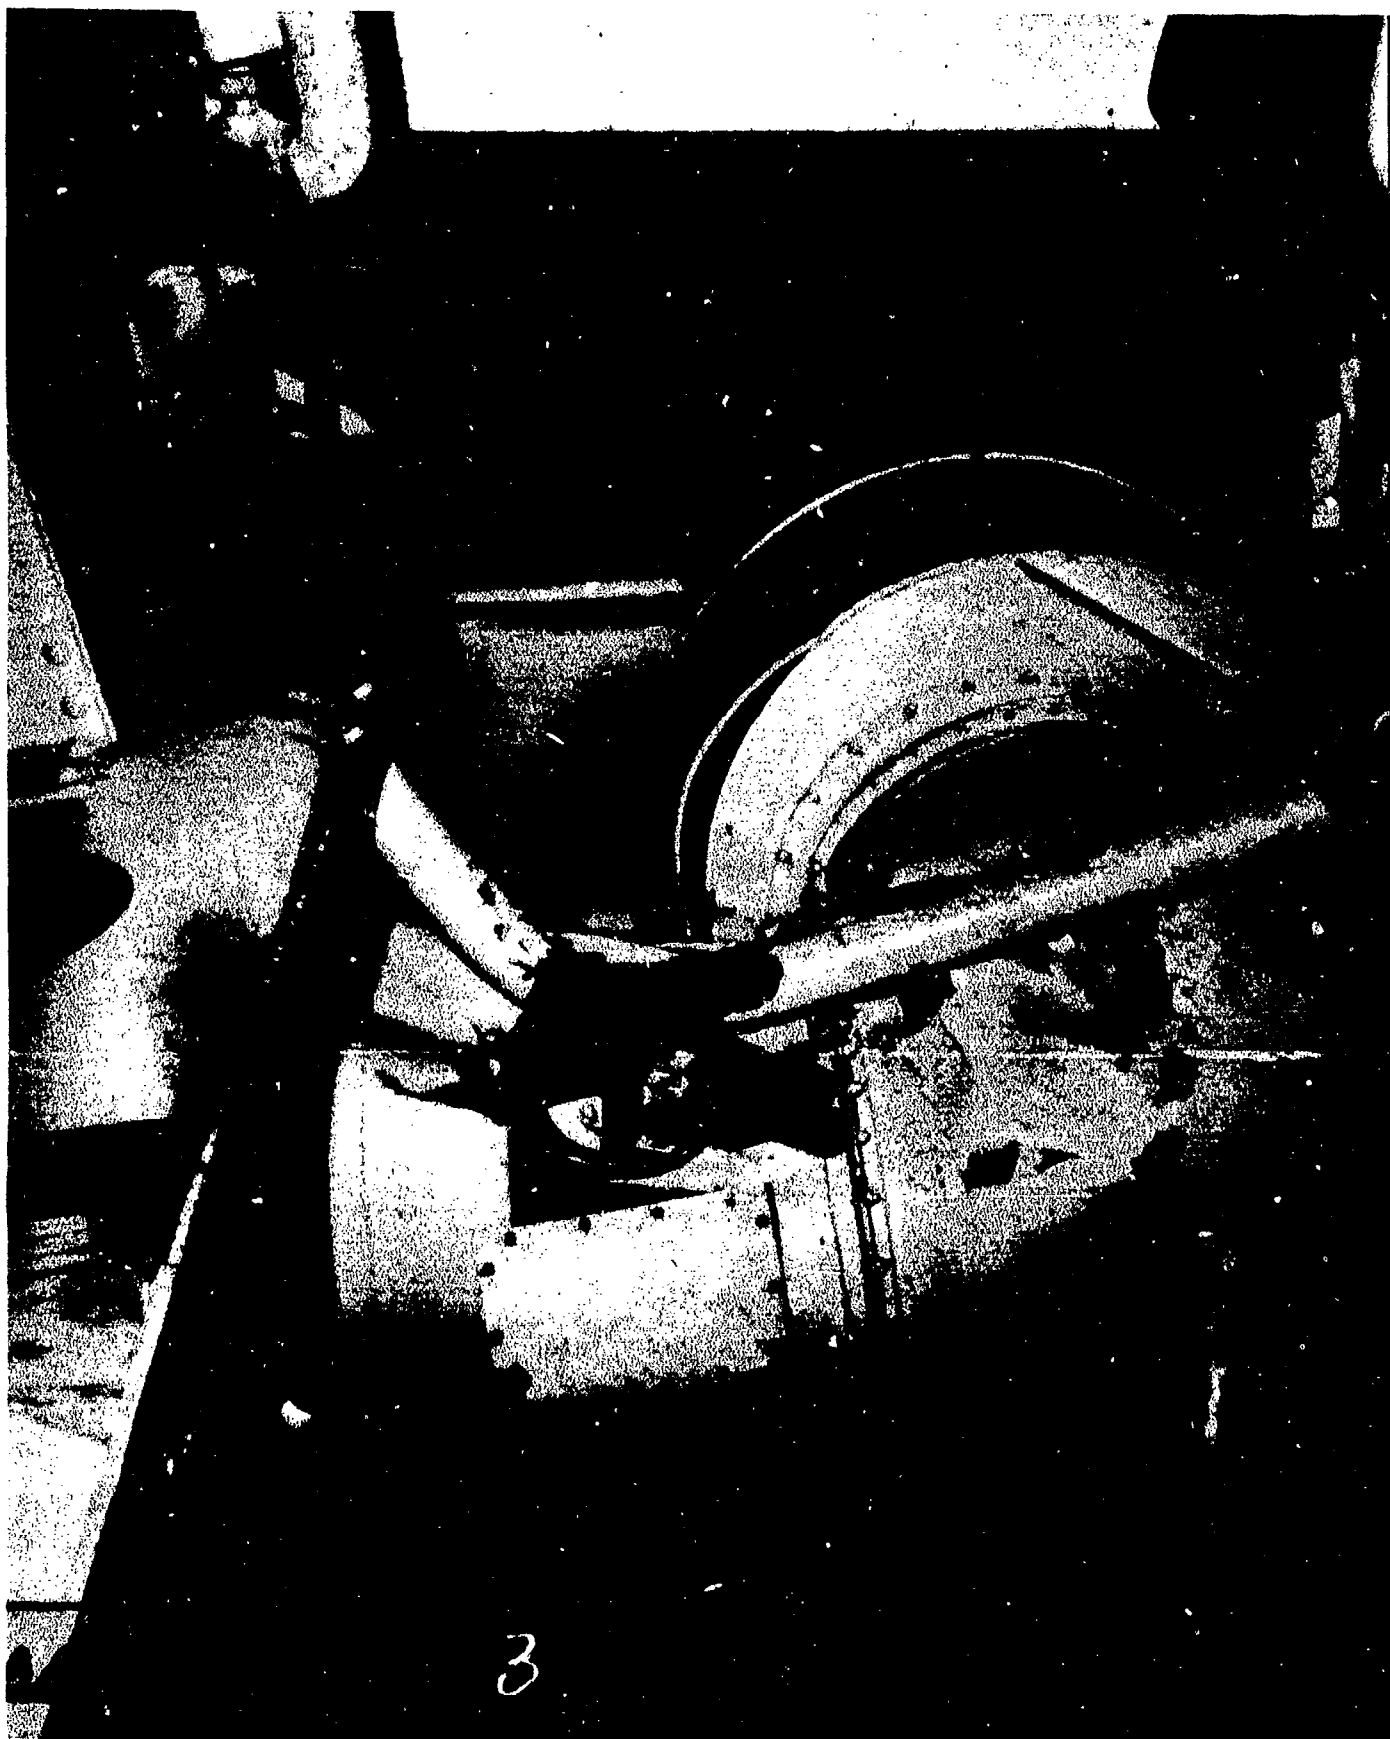
AA-CR-175-2178-3. Looking to port on 2nd deck showing failure of center-line stanchion at web frame 125 and damage to blower duct.

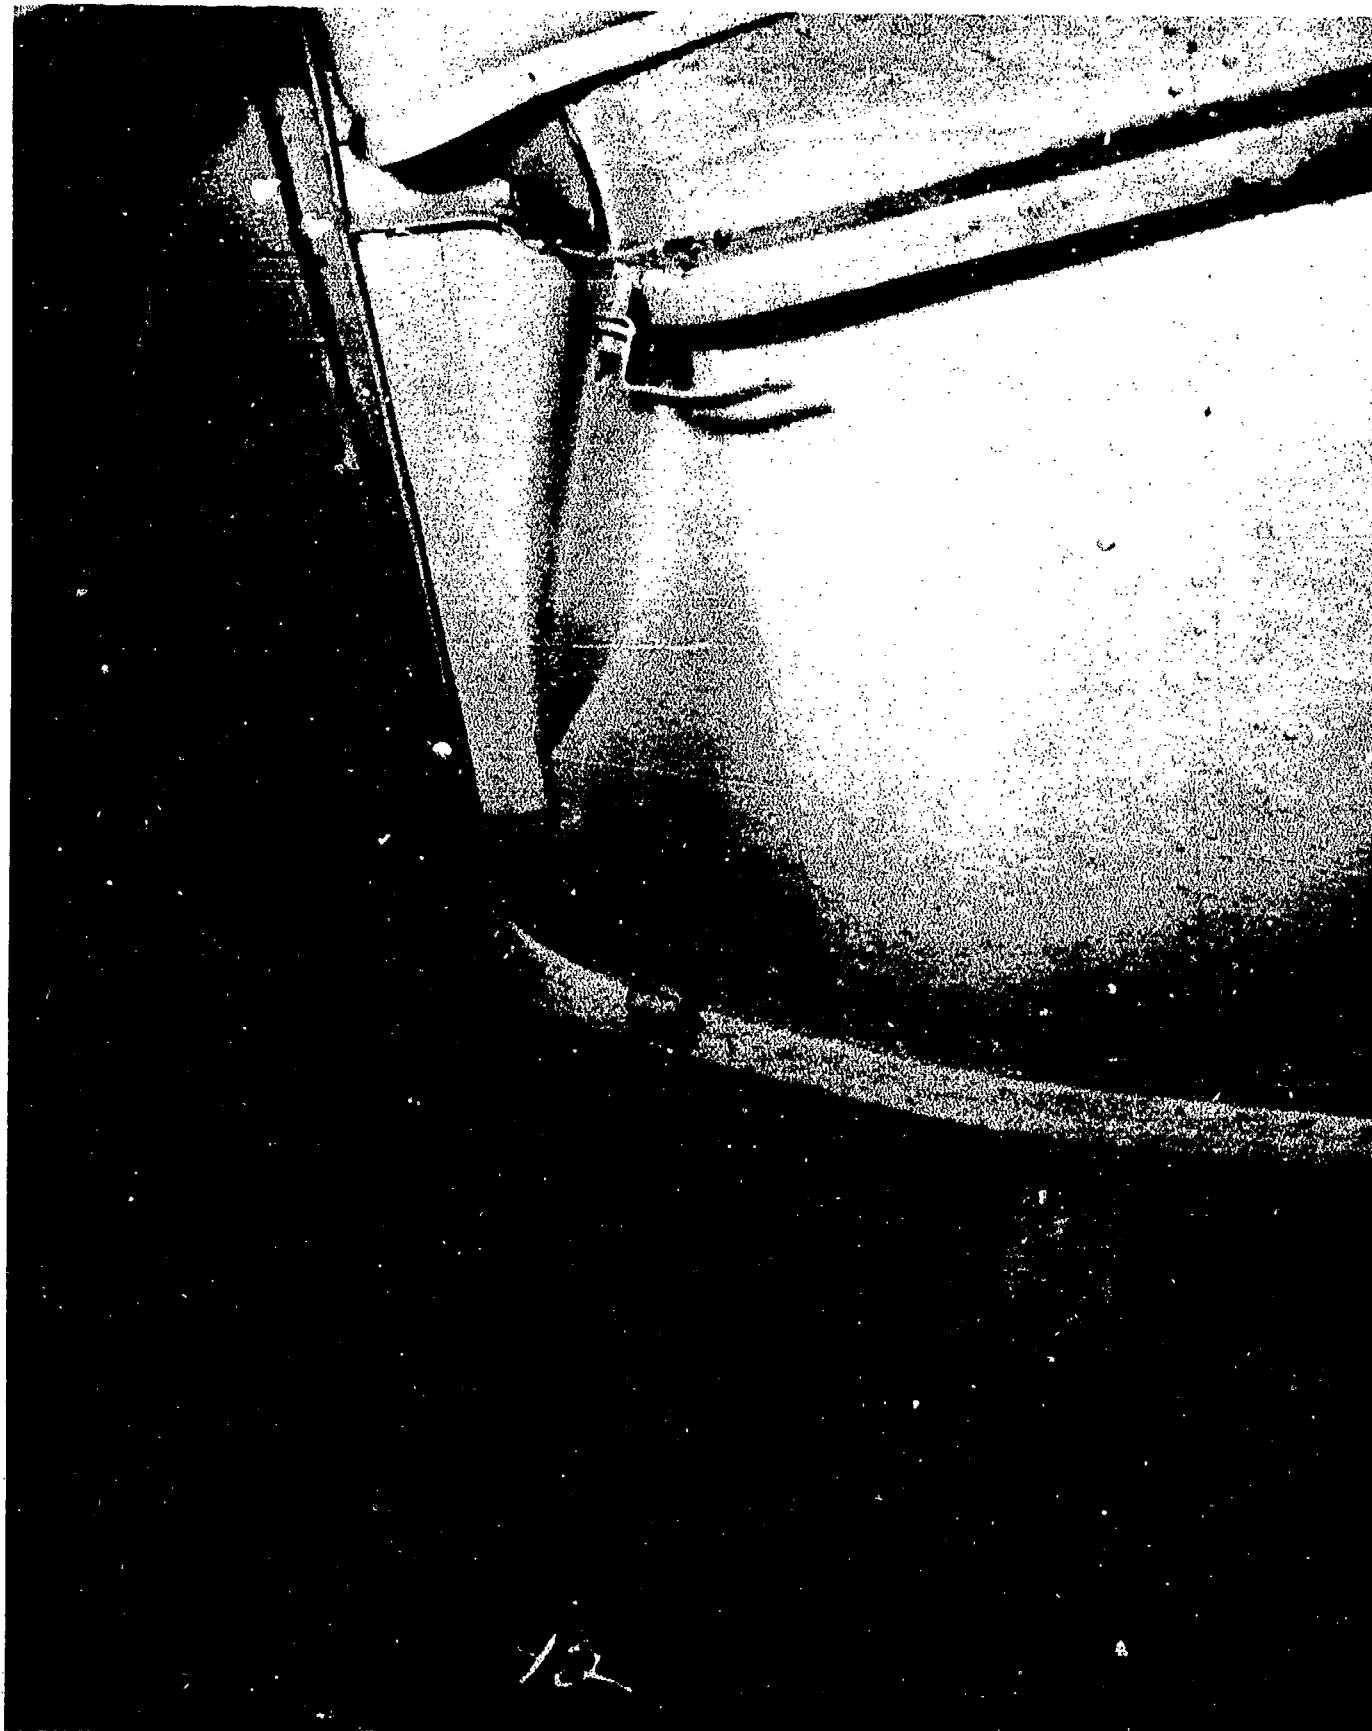
AA-CR-175-2178-12. Looking aft and to starboard shell on 2nd deck showing damage to bulkhead 128 and web frame.

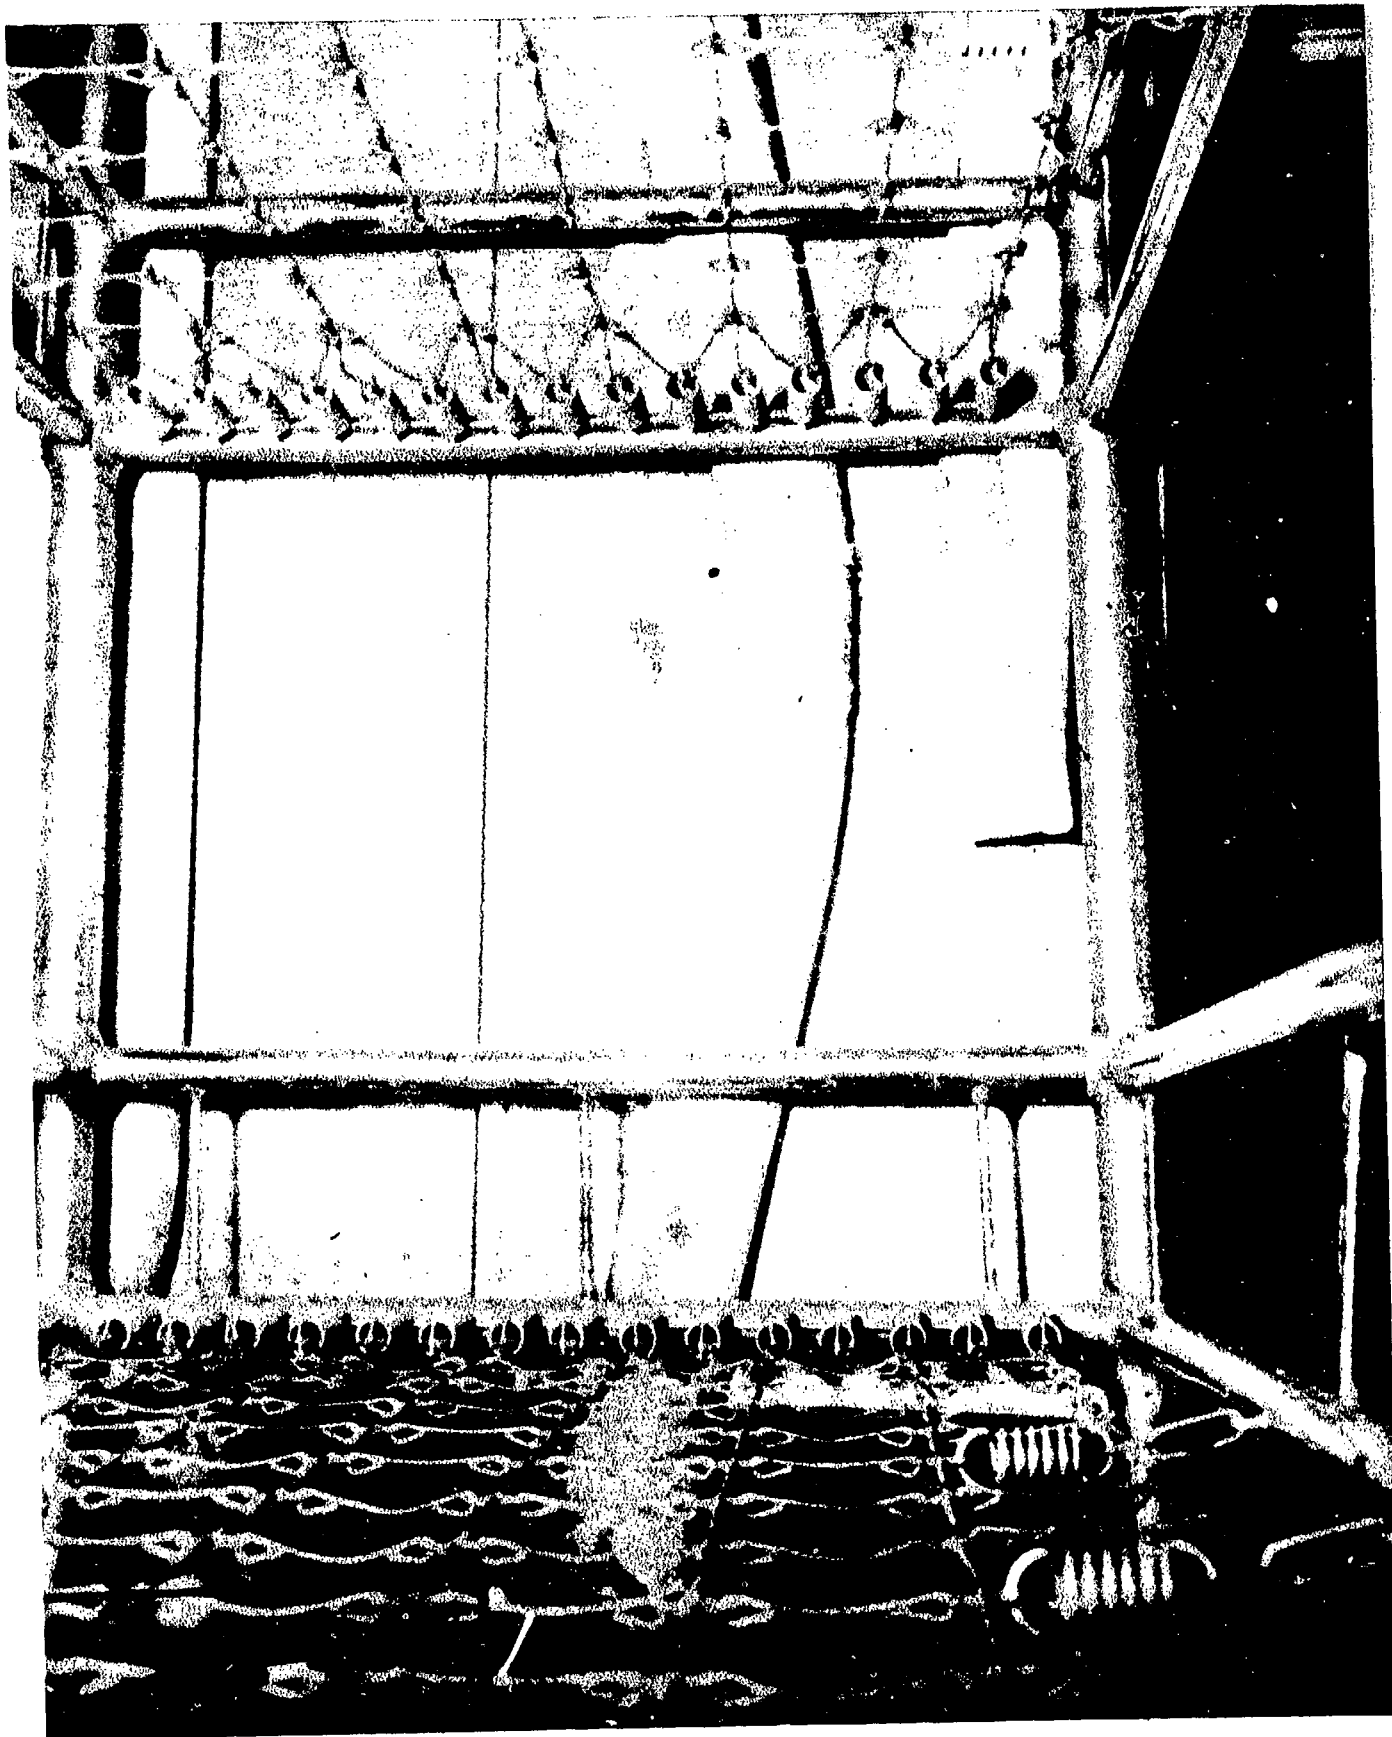
AA-CR-175-2180-1. Looking forward on 2nd deck showing failure of center-line stanchion at frame 135 in C.P.O. quarters.

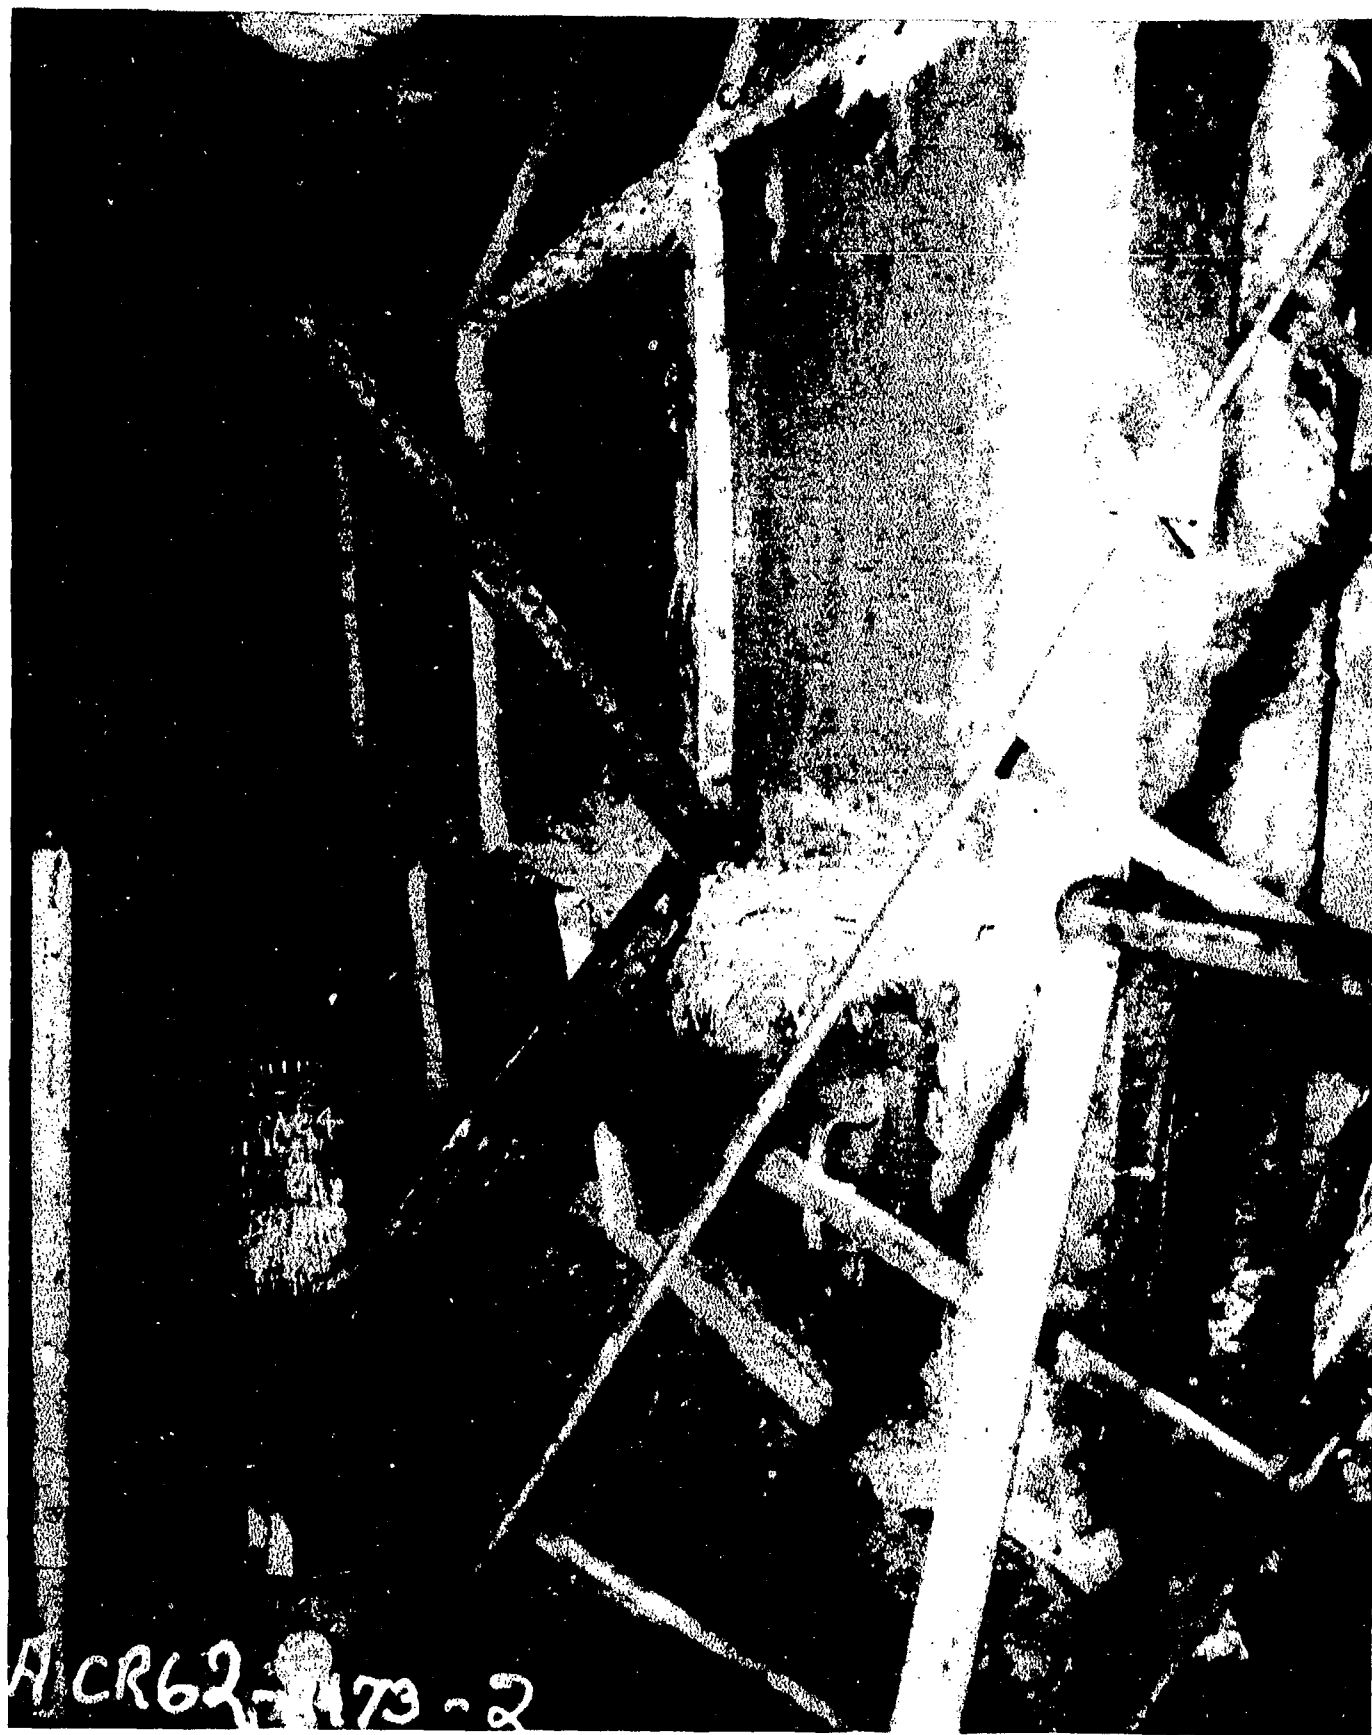
AA-CR-62-2173-2. #7 Boiler, repaired outboard casing.

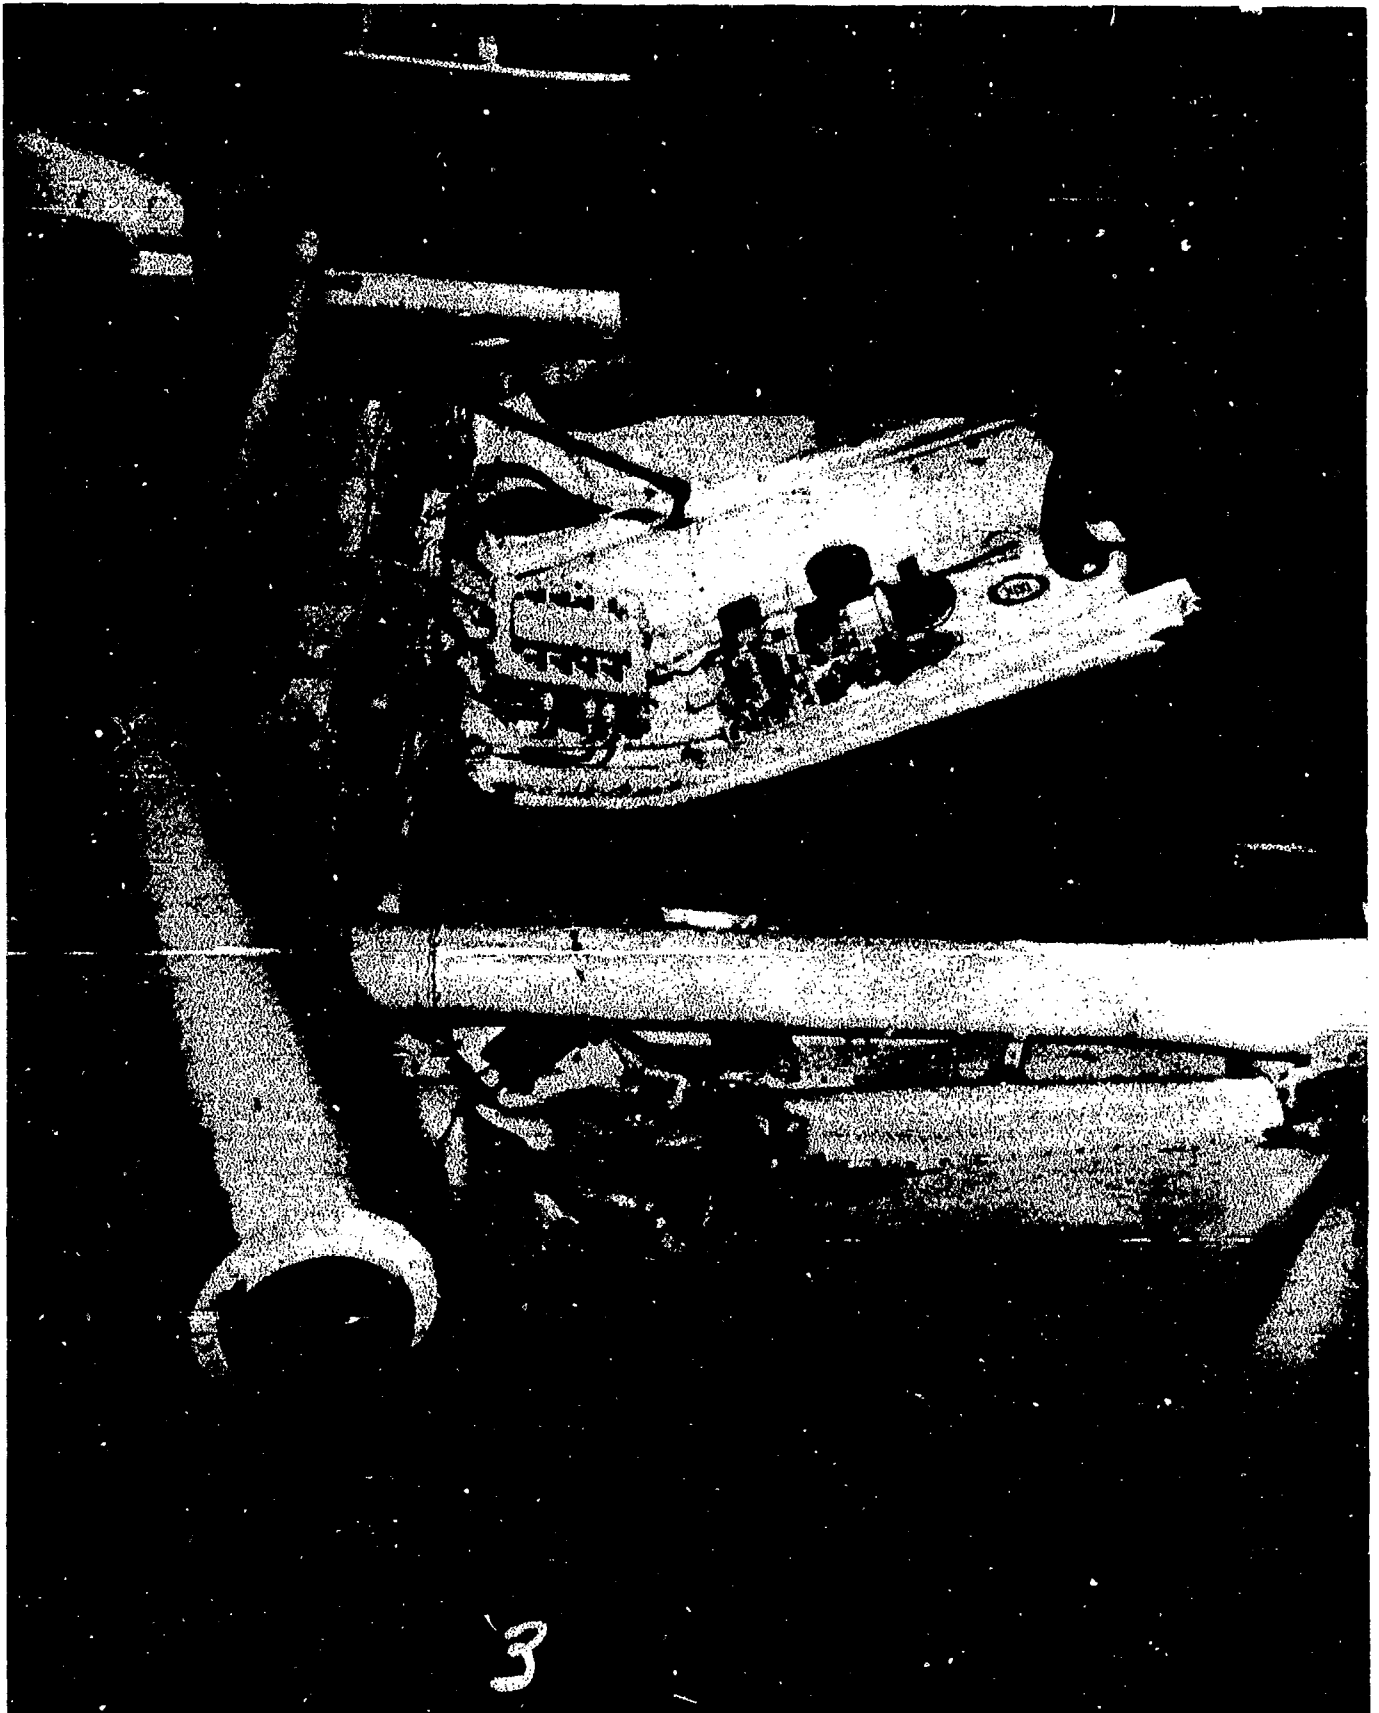
AA-CR-68-1755-3. Various electrical wiring and appliances on ruptured bulkhead.
